Total Land Subsidence in the Eloy Sub-Basin, Pinal County  
Based on Radarsat-2 Satellite Interferometric Synthetic Aperture Radar (InSAR) Data  
Time Period of Analysis: 2.0 Years 04/19/2015 To 03/15/2017

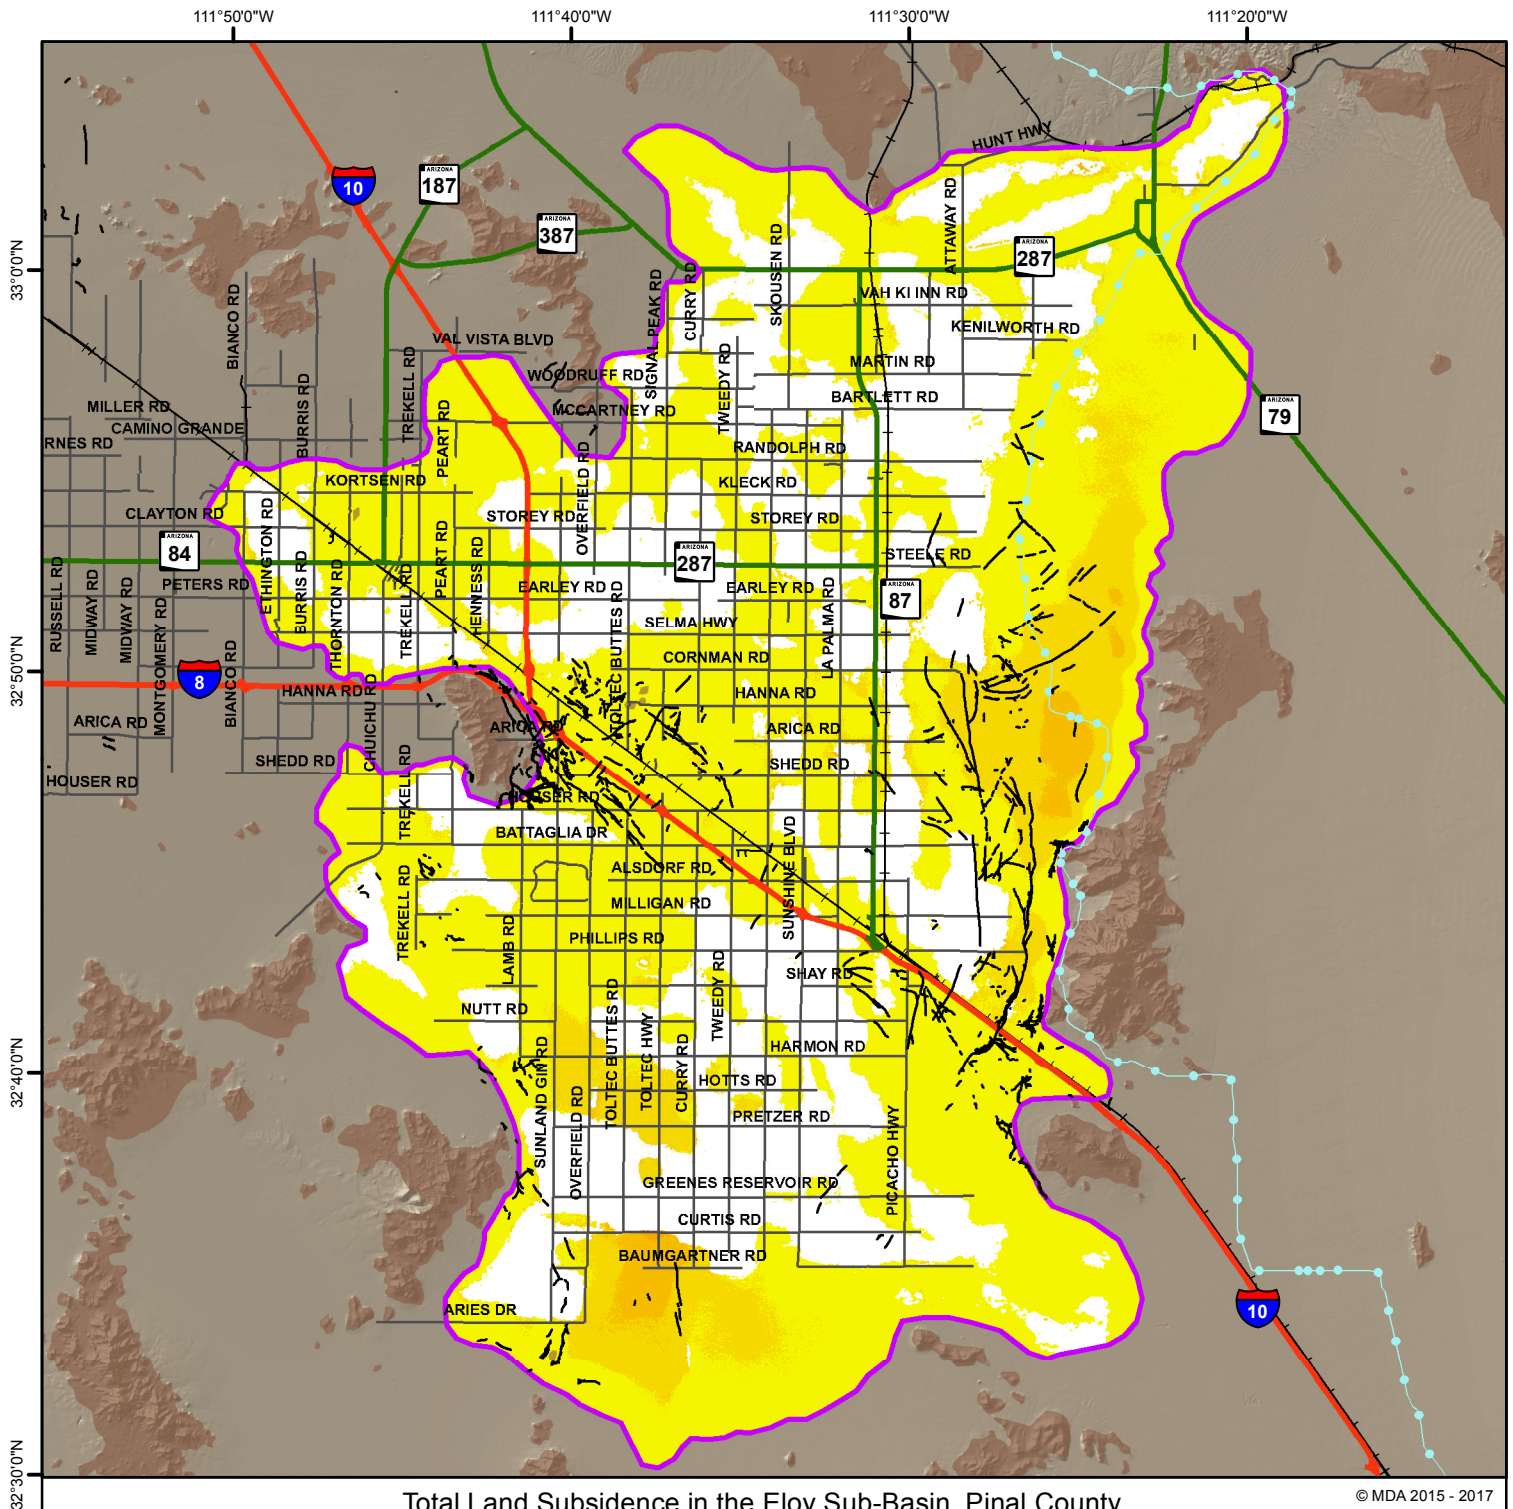
Decorrelation (white areas) are areas where the phase of the received satellite signal changed between satellite passes, causing the data to be unusable. This occurs in areas where the land surface has been disturbed (i.e. bodies of water, snow, agriculture areas, areas of development, etc).

Earth fissures were mapped by the Arizona Geological Survey. For information on earth fissures visit: [www.azgs.gov/EFC](http://www.azgs.gov/EFC)
